RESTORATION OF THE STEAM SCHOONER WAPAMA

Report #1 to the State of California
Division of Beaches and Parks,
on the History and Restoration of the

WAPAMA

by the
San Francisco Maritime Museum

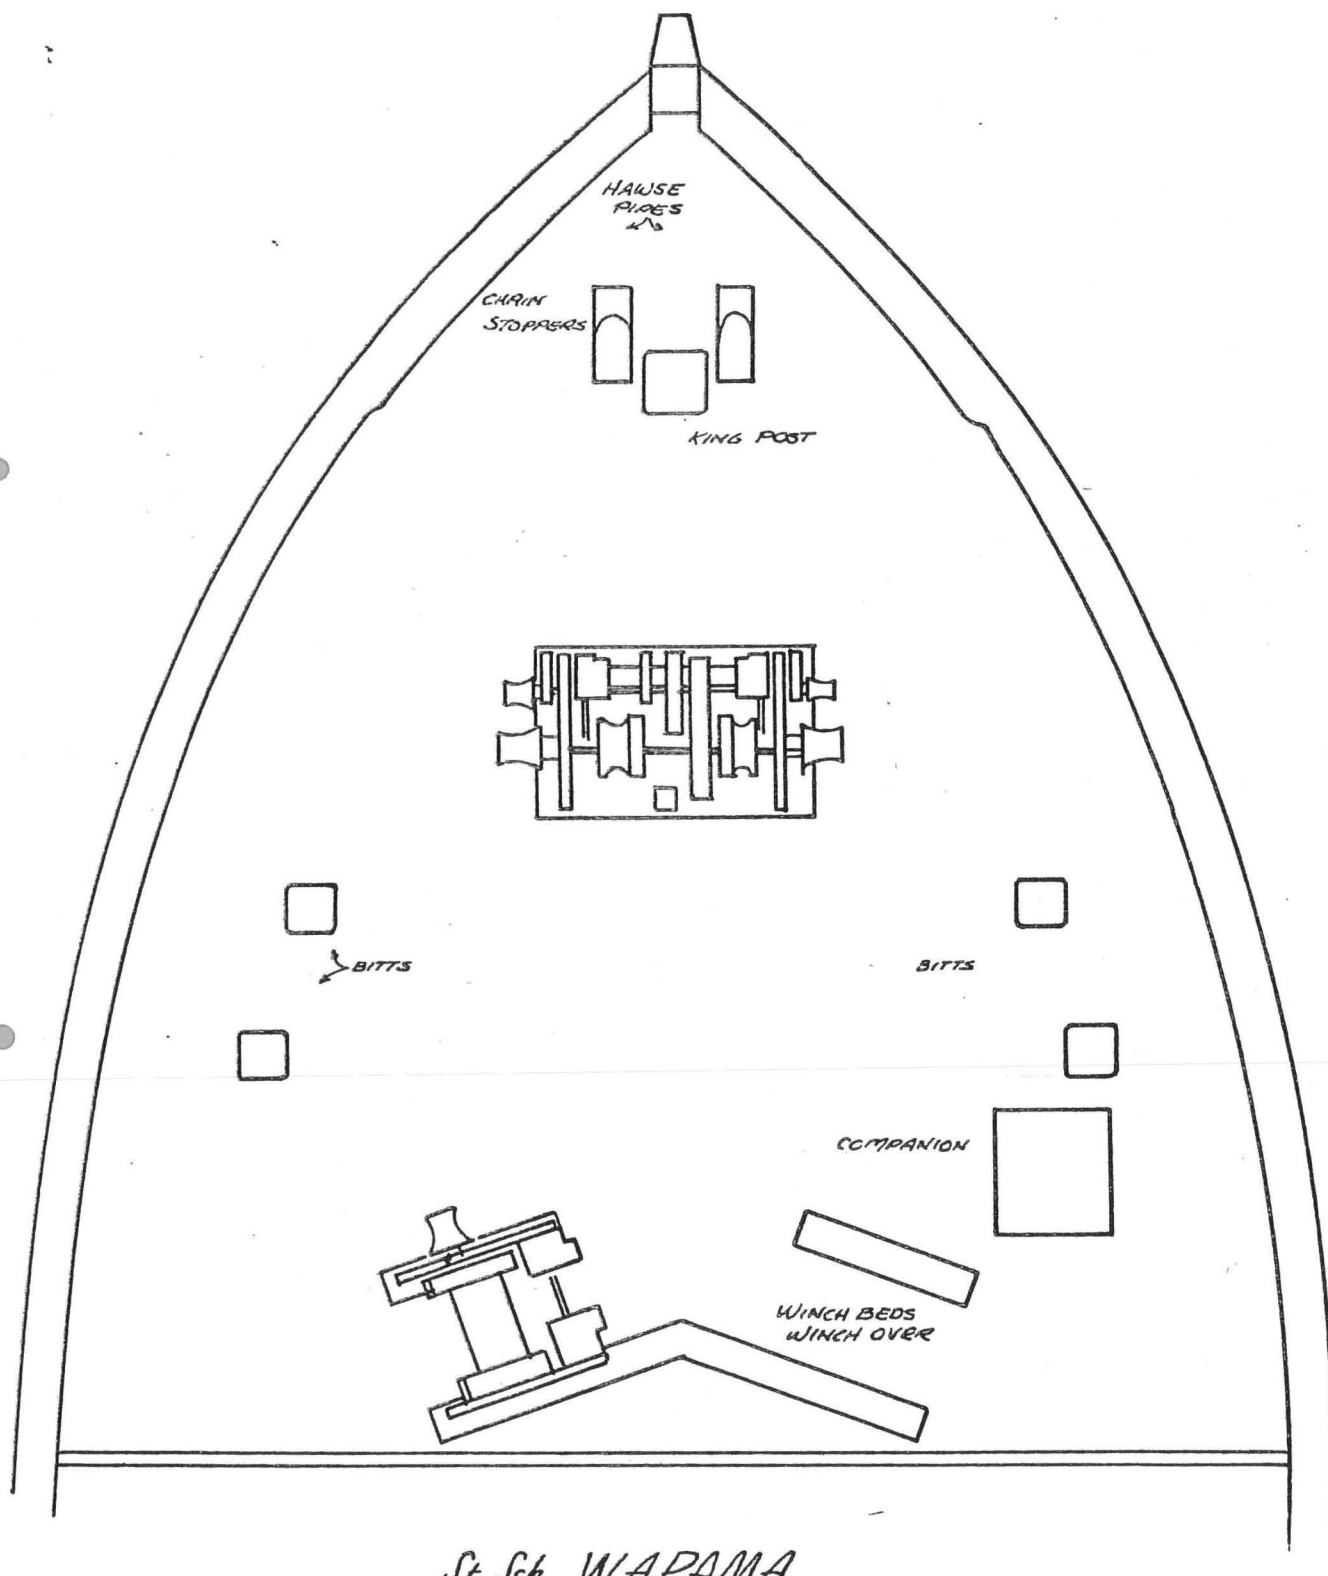
St. Sch. WAPAMA
 FORECASTLE-HEAD DECK ARRANGEMENT
 SCALE $3/16" = 1'$

The forecastle head is in comparatively poor condition, with more or less deterioration apparent in all parts, from the stem-head to the beam at the after end of the forecastle, and including the covering board, bull rails, bitts, winch and windlass beds and decking. The condition of the decking around the machinery beds and at the outboard after ends of the forecastle deck is such that it will require the replacement of most of the decking, and it will probably prove advisable to finish the job with an entirely new deck.

that it may be necessary to replace it completely, and recent removal of some of the decking has shown that the beams forward of this are soft in many spots.

Potentially more serious is the condition of the covering board, which is so soft in many places that it will not admit of recaulking the outer deck seam; this is another of those places in which extreme caution should be used in tearing out rotten wood, lest the job "snow-ball" into a project larger than it is desirable to undertake at this time.

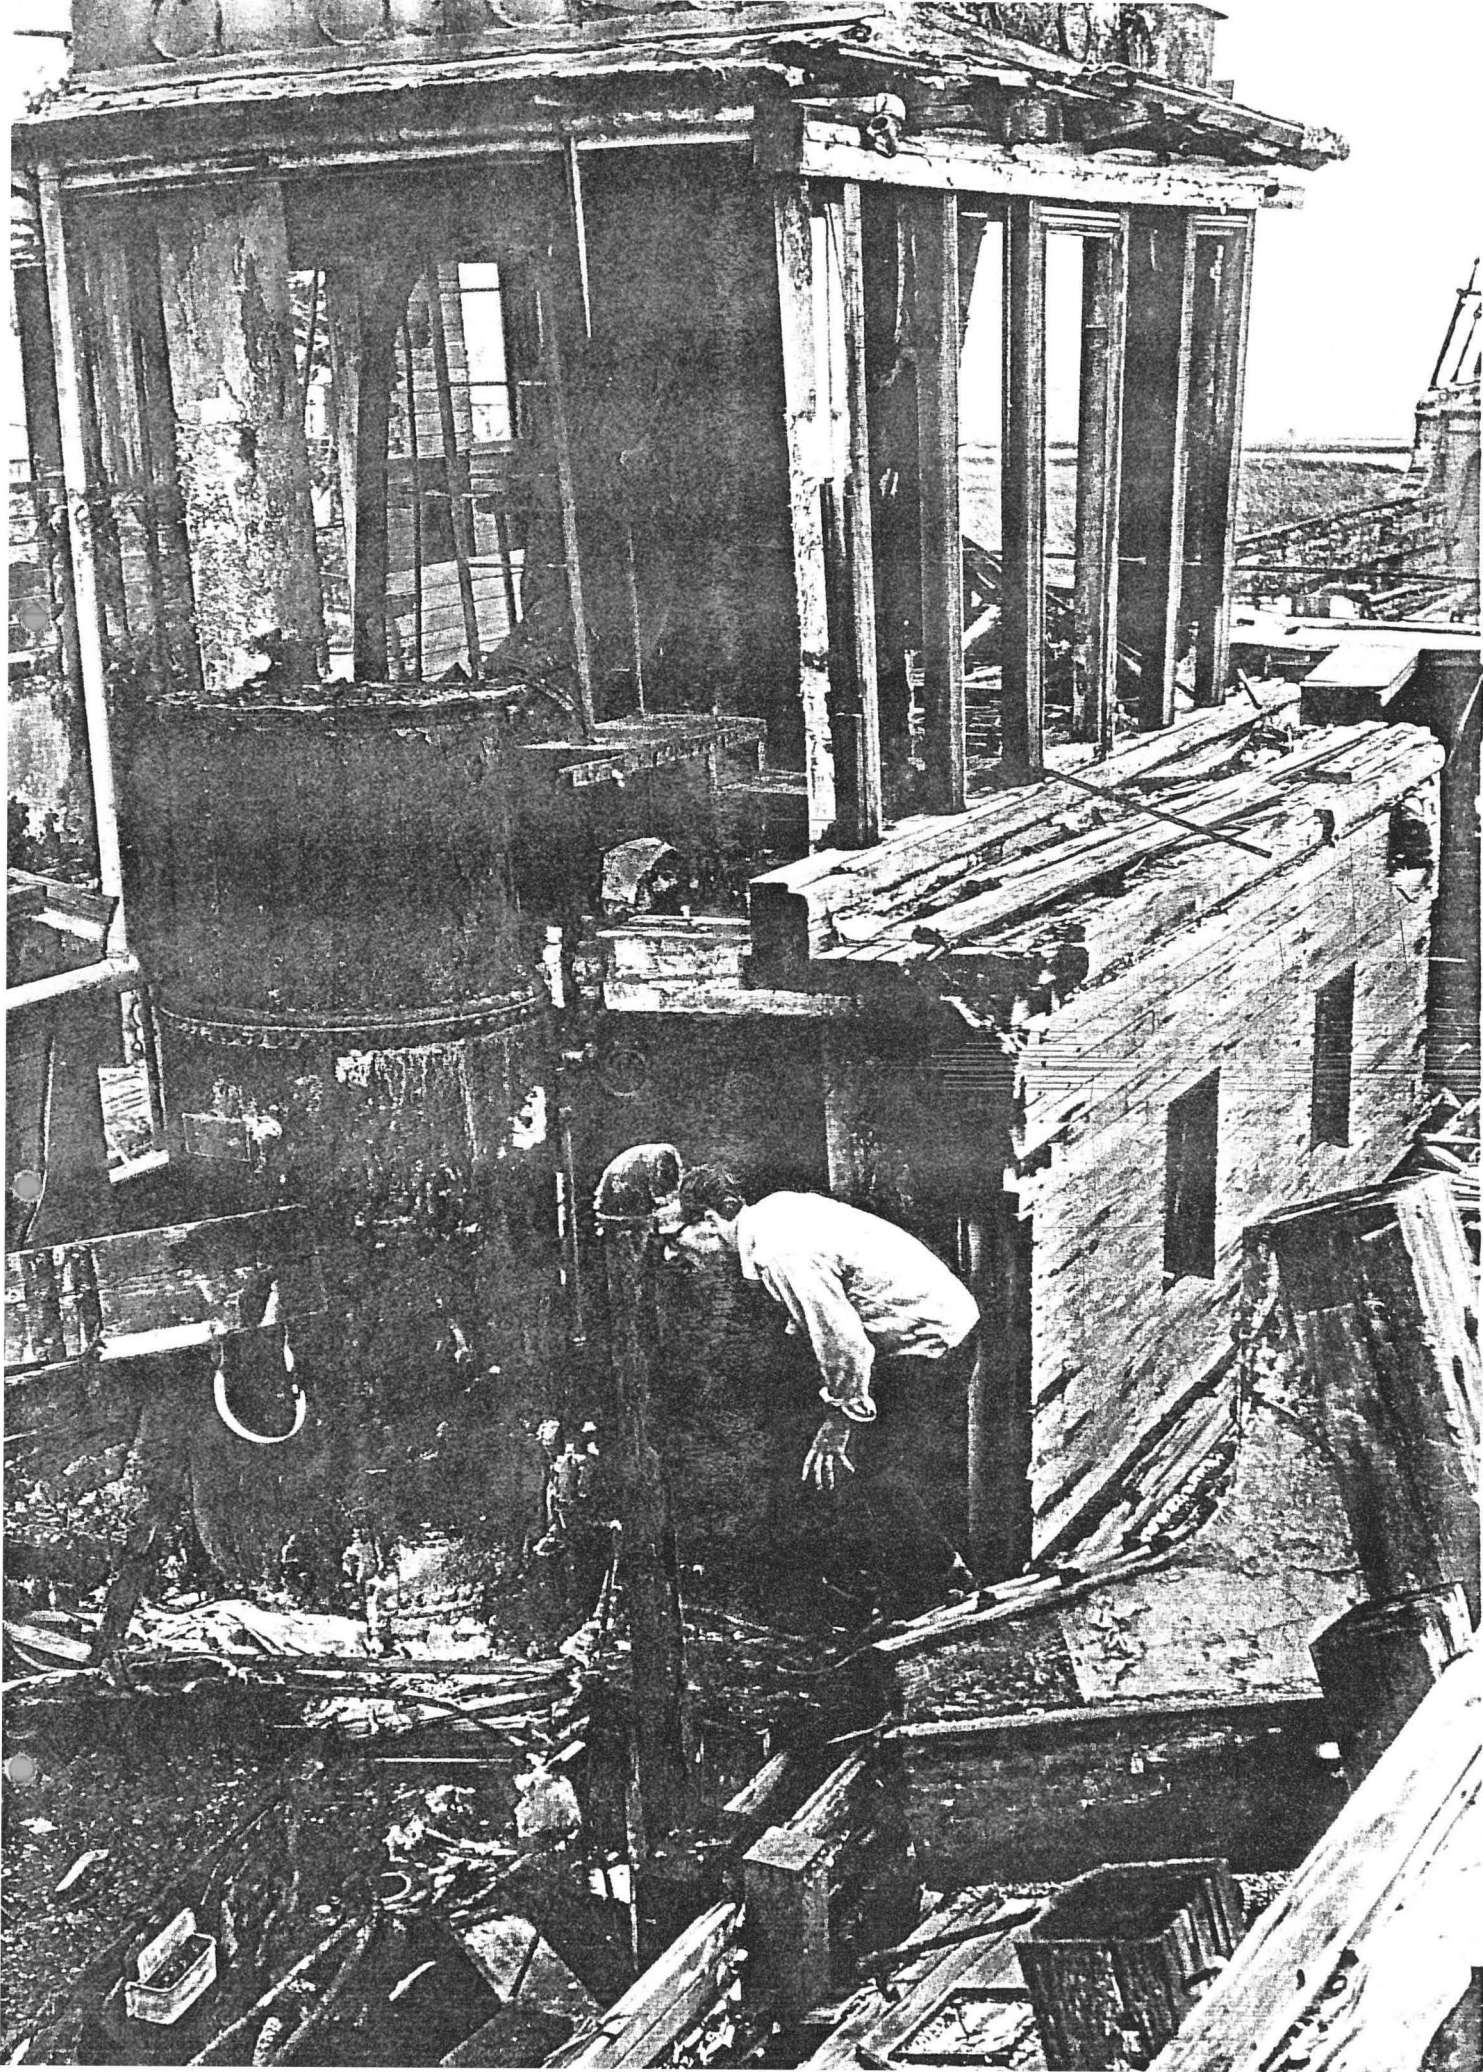
Those knees under the winch platform -- which immediately attract the visitor's eye -- are hollowed-out by dry rot; severe leaks between the pilot house and fidley have rotted decking and beams not only on the boat-deck level but down through two decks, into the bulkheads and sheathing of the firemen's quarters on the main deck.

This "cutaway" view of the CELILO's superstructure shows the heavy construction of steam schooners and the potential magnitude of what may start as superficial restoration.

The WAPAMA is badly deteriorated around and under the funnel casing (top), and years of fresh-water leakage have resulted in rot spreading downward through the cabin-deck (center).

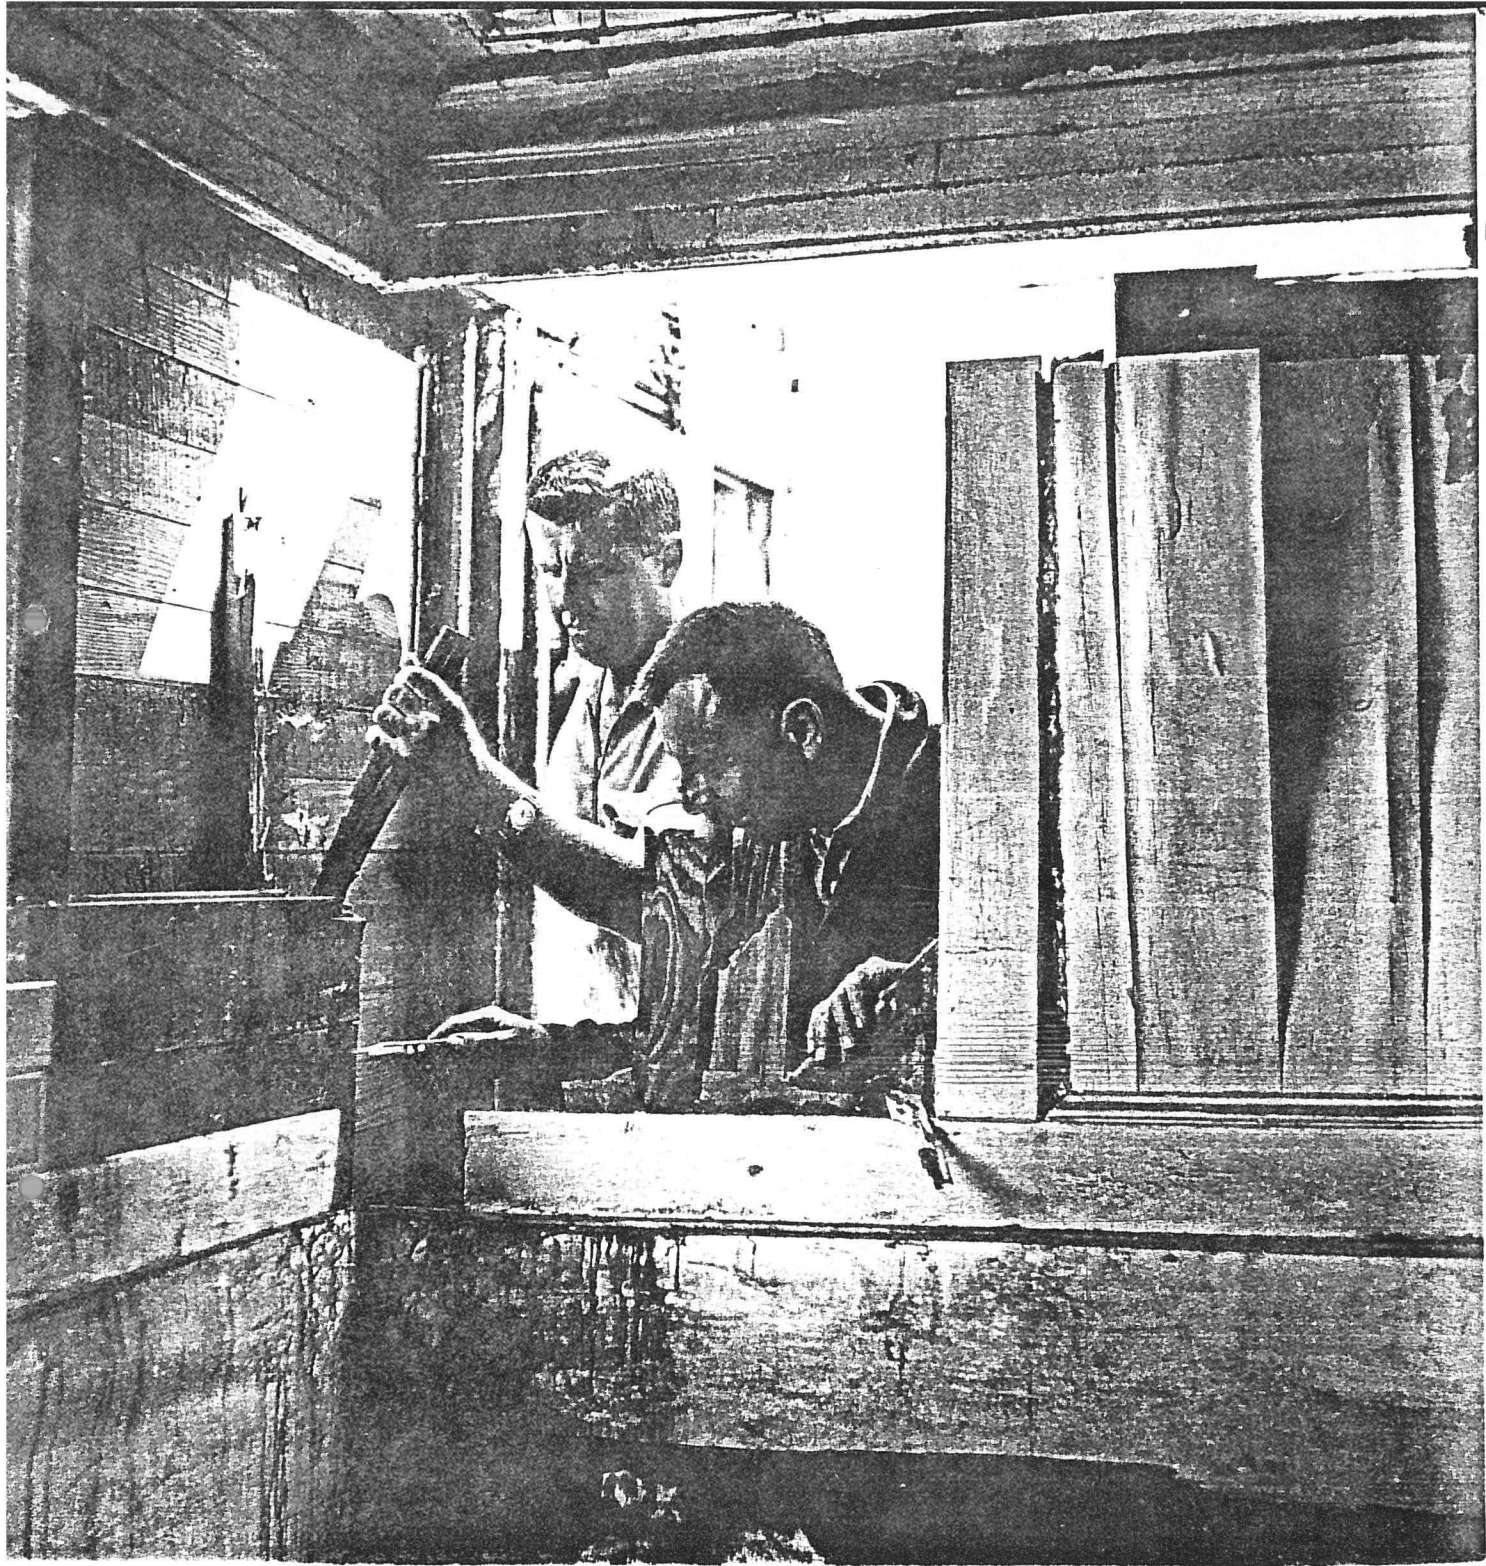
HIDDEN ROT

The fancy paneling of this room is almost completely ruined, and deterioration of the studs and sheathing is far advanced in places. Here is a case where the major portion of the structure can be saved, but where the patching and replacement of parts assumes the proportions of a major rebuilding job. Generally, the entire superstructure on this poop level is in the same condition, and for this reason it would seem wise to attempt restoration of only those areas which are of special interest at this time.

Restoration and Maintenance Supervisor Harry Dring (left) and Harold Sommer, Maritime Museum restoration expert, probe the rotten paneling and structure of the WAPAMA's lounge.

The removal of buckled panels reveals rotten sheathing, which in its turn conceals deteriorated studs. Thus, while it is possible to judge the probable extent of the restoration which will be required in any given area, it is difficult, and often impossible, to determine what repairs will be necessary in detail.

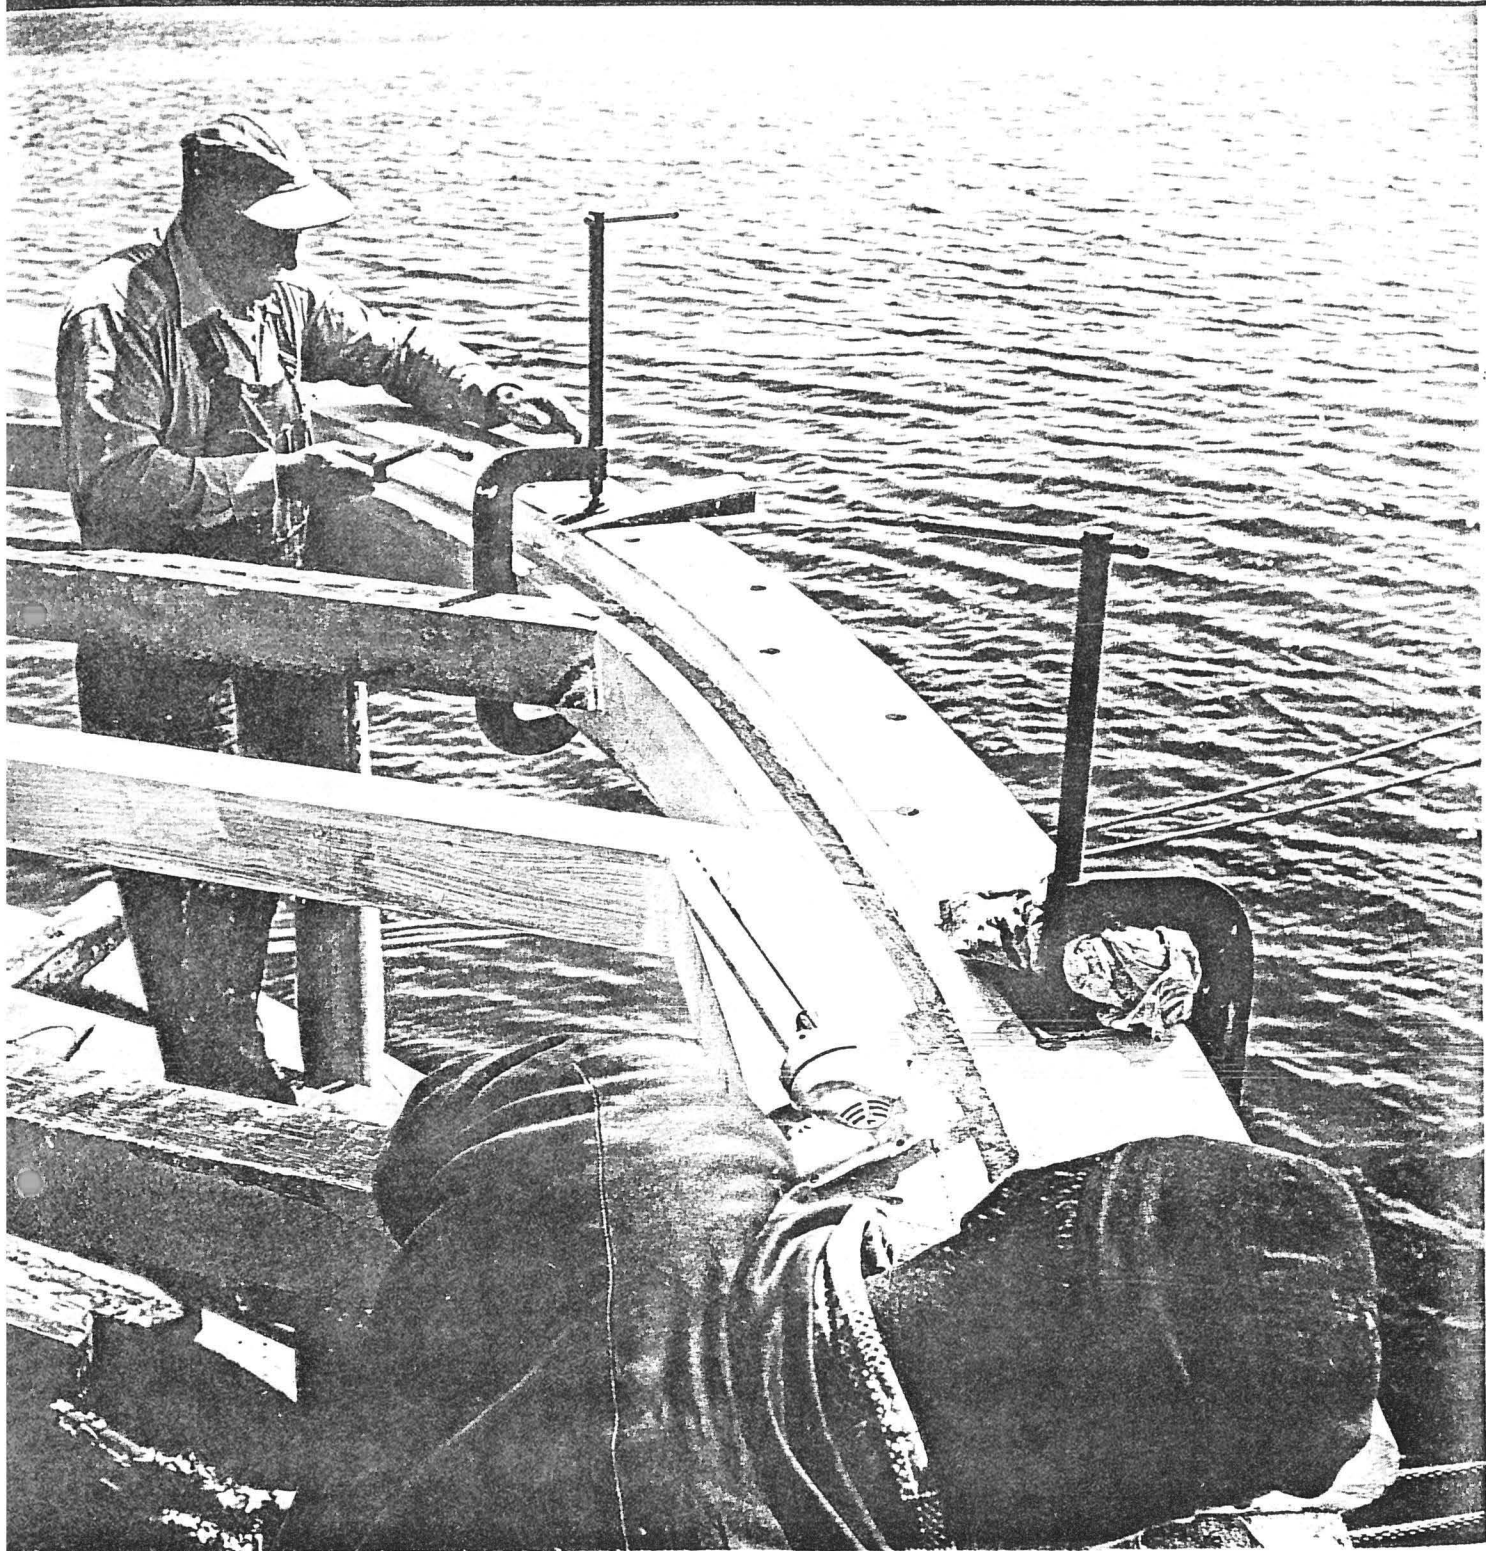
Heavy shaped timbers offer one of the most striking distinctions between ship repair and most "shoreside" construction. Note that the stanchion and three of the beams are old, while one beam, the massive plate that the beams are notched into, and the covering board, are new.

It is in such work as this that great savings have been made by employing highly-skilled shipwrights rather than letting the work out on contract. The slow pace of this tedious piece of work did not affect other jobs, and by careful selection of used timbers from a wrecking firm it was possible to save about \$300 on the lumber visible in this photograph.
